Subject: Building Assessment for Code Compliance  
(excluding MEP & Struct.)

January 25, 2019

Project Name: Peaceful Spirits Building  
Location: 269 Mouache Drive  
Ignacio, CO 81137

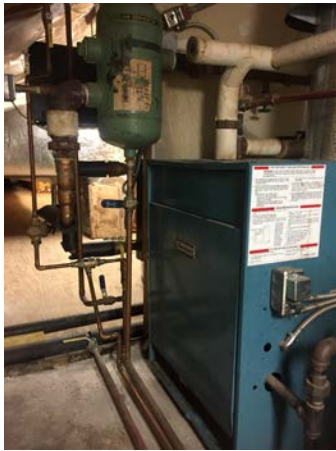
1. Heating. The building is served by two Burnham 806B-WI cast-iron, atmospheric boilers piped in a primary-secondary configuration. The combined capacity of the units at elevation is estimated to be 412,000btuh. (Photo 1)

According to the manufacturer they no longer keep records on this unit. It was manufactured sometime in the 1980s. ASHRAE (American Society of Heating Cooling and Refrigeration Engineers) lists the median life of cast iron boilers to be 30 years. These boilers appear to have been installed mid-1980s indicating replacement will likely be necessary. Boiler efficiency at sea level is listed at 78%. At site elevation (6,450' ASL) and being 30 years old the boiler output most likely has an efficiency of <70%

While the boiler access does meet the 30" deep x 30" wide access required from the IMC 306.1 in front of the equipment it does not meet the 80" passageway height requirement of 306.2. Flue terminations may be within 18" of combustibles at ceiling penetrations 803.10.6 and should be provided with a thimble at the ceiling penetration. The vent terminations appear to be within 4' of operable skylights 804.3.5.4.

Photo1: Boiler Room

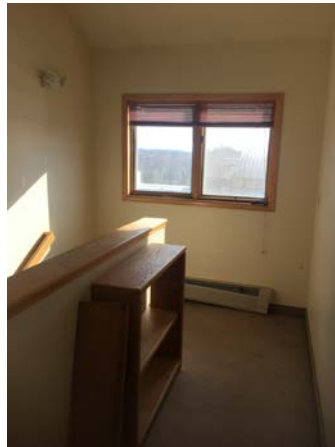
Photo 2: Busted Baseboard

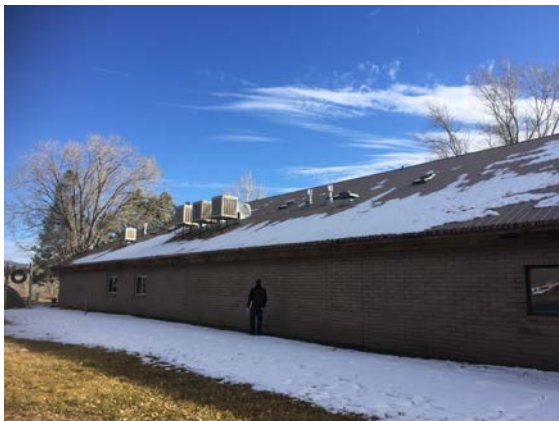
2. Cooling. There (4) roof mounted and (2) attic mounted evaporative coolers that provide cooling for the facility. The current location of the roof mounted units does meet 306.5.1, which requires platforms, and guardrails, be provided when the angle of the roof is equal to or exceeds 25% (3/12). An electrical receptacle is also required per 306.5.2. (Photo 3) The attic mounted units are too wide to be removed and replaced without dismantling the equipment. There does not appear to be a method to close outside air ductwork (eg. outside air damper, exterior cover, etc.) when equipment is not in use per 2015 IECC C403.2.4.3. The only method in place to relieve building pressure is through operable windows.

Photo 3: Roof mounted evaporative coolers

- H. Replace the evaporative coolers with packaged, gas-fired, pad mounted rooftop units ducted to the existing ceiling and floor register locations. This will satisfy the heating, cooling and ventilation needs of the building.
- I. Remove and dispose of boiler plant.
- J. Replace ductwork.
- K. Replace floor registers.
- L. Replace ceiling exhausters
- M. Remove and dispose of baseboard heaters. Patch and repair scarred surfaces.

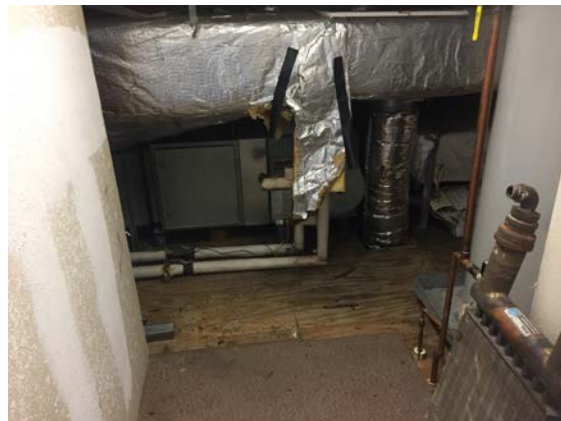
The existing kitchen appears to have had an exhaust hood and sidewall exhauster both of which no longer exist. The floor and walls have short-term patches at both locations. The makeup air unit, now abandoned in place, is a McQuay model LHD103CH air handler with its hydronic heating coil removed and laying nearby. (Photo 4)

Photo 4: Makeup air unit

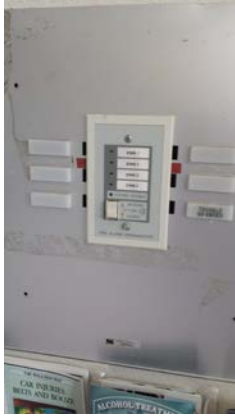
1. Abandoned fire alarm control panel at entry foyer should be removed.
2. Existing detectors are not up to NFPA 72 mounting and coverage standards in vaulted ceiling areas,

Photo 5: existing, unused fire alarm panel at entry

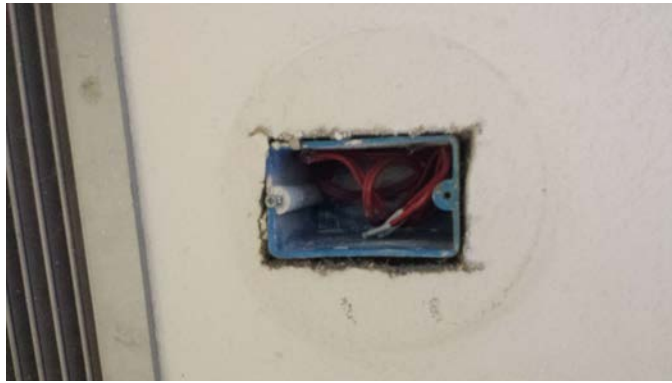
Photo 6: Missing fire alarm device

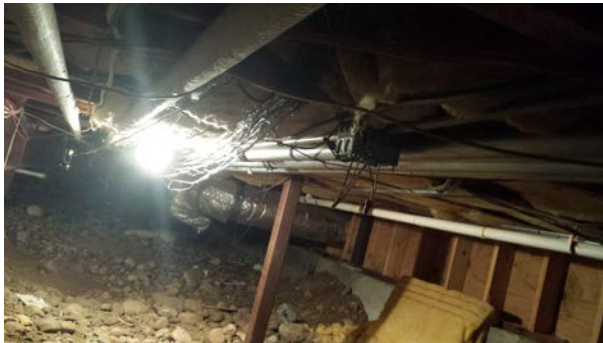
- c. Communications cable in crawlspace not properly supported
  - d. Communications cable in attic not properly supported
  - e. Mechanical rooms: various open j-boxes with exposed conductors and splices. Various conduit and MC cables not supported according to code.

Photo 7: Unsupported crawl space cabling, open j-boxes

- E. Replace branch circuits as required to make all receptacles ADA compliant.
- F. Remove frogeye egress lighting. Replace lighting and controls with new LED type fixtures. Provide new LED fixtures with integral battery backup as needed for egress lighting.
- G. Support all conduit and MC cable per NEC.
- H. Support all communications cable to prevent kinking and chafing.
