Red Cedar Gathering Company  
Arkansas Loop to Coyote Gulch Interconnect  
Carbon Dioxide Sequestration Pipeline Project  
*Aquatic Resources Delineation Report*

## Executive Summary

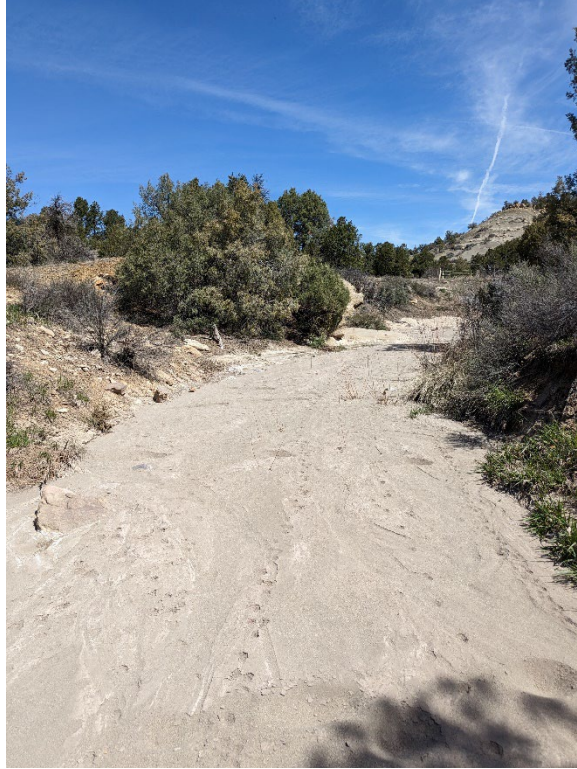
No surface water or saturated soils were observed within Gaines Canyon. In addition, no hydric vegetation was associated with the drainage. However, the drainage does exhibit a defined bed and bank, with a pronounced transition from the sandy-bottomed wash to sparsely vegetated upland containing big sagebrush (*Artemisia tridentata*), fendlerbush (*Fendlera* sp.), piñon pine (*Pinus edulis*), rabbitbrush (*Ericameria nauseosa*), and Utah juniper (*Juniperus osteosperma*).

Photo 1. View upstream of Gaines Canyon drainage at crossing (ID: 1a). Photo taken 5/4/2023.

The proposed pipeline alignment crosses through the Gaines Canyon drainage three times, resulting in impacts to approximately 144 square feet (0.003 acre) of temporary impacts. Gains Canyon is classified by Cowardin, et al. (1979) as Riverine – Intermittent – Stream Bed – Sand. No excavated material would be stored within this drainage during construction.

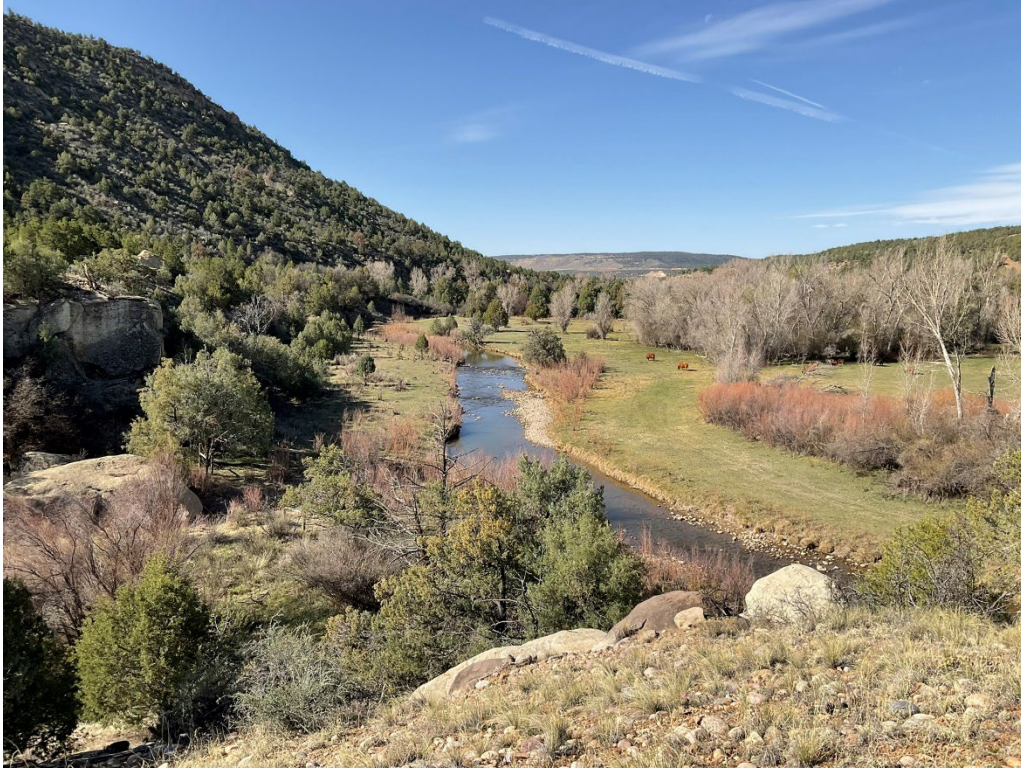
The Florida River channel is classified by Cowardin, et al. (1979) as Riverine – Upper Perennial – Unconsolidated Bottom. The west side of the river has been converted to agricultural use, with evidence of livestock grazing up to the bank of the river. In addition, the proposed pipeline follows an existing pipeline ROW through this area, overlapping previous disturbances from construction. There are isolated patches of cottonwood (*Populus* sp.) and coyote willow (*Salix exigua*) throughout the active floodplain and low terrace on the west side of the river. A fringe of coyote willow occurs on the east bank of the river, before quickly transitioning into sparsely vegetated upland habitat. However, no palustrine wetlands were delineated adjacent to the Florida River at the proposed pipeline crossing.

*Photo 2. View south (down-river) of Florida River at proposed pipeline crossing (ID: 2). Photo taken 4/22/2022.*

The proposed pipeline crosses the Florida River at a point measuring approximately 44 feet across from bank to bank and would result in approximately 2,200 square feet (0.05 acre) of temporary impacts to this resource. In addition, temporary fill within the river would be up to 39 cubic yards of material.

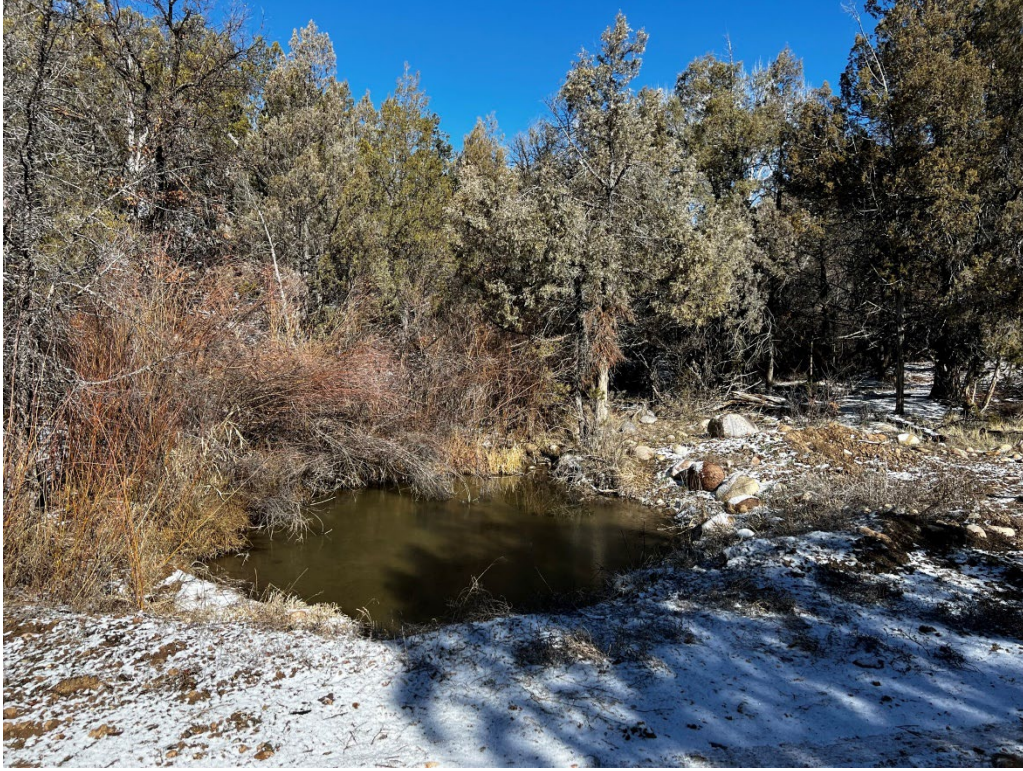
The Unnamed Drainage I is a high gradient system originating on the Florida Mesa and joining the Florida River approximately 1,200 feet down-gradient of the proposed pipeline crossing. During a site visit on April 5, 2023, a small amount of water was impounded within the drainage above the existing dirt road (as shown in Photo 3). There is a culvert channeling flows within the drainage beneath the road, which may have been blocked at the time.

The drainage is mostly vegetated along the banks with coyote willow, however immediately transitioning to piñon-juniper woodland. This drainage is classified by Cowardin, et al., similarly to Gaines Canyon as Riverine – Intermittent – Stream Bed, however, exhibits a Rubble subclass. Temporary impacts to Unnamed Drainage I are 64 square feet (0.002 acre). No excavated material would be stored within this drainage during construction.

*Photo 3. View upstream of Unnamed Drainage 1 crossing (ID: 3) from dirt road. Photo taken 4/5/2023.*

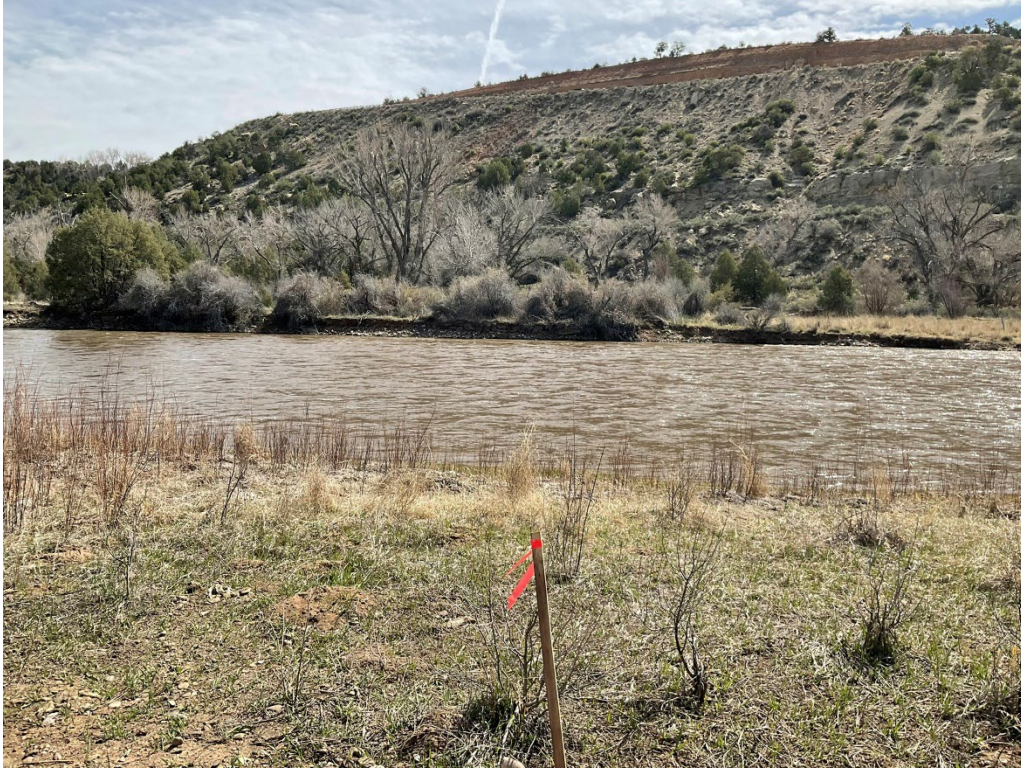
As mentioned previously, the Animas River is the primary surface water resource in the project area. This interstate water has its origin in the San Juan Mountains near Silverton, Colorado and flows southerly into the San Juan River in New Mexico. The river is evenly influenced by spring snowmelt and summer monsoonal storms within the watershed. Irrigation diversions and return flows also have an effect on the discharge within the river.

The Animas River channel is classified by Cowardin, et al. (1979) as Riverine – Upper Perennial – Unconsolidated Bottom. The proposed pipeline crosses the Animas River at a point measuring approximately 133 feet across from bank to bank. Construction activities would utilize the entire 40-foot-wide ROW and a Temporary Use Area immediately to the north at the Animas River crossing, resulting in approximately 7,980 square feet (0.183 acre) of temporary impacts to this resource. Temporary fill within the river channel would be up to 118 cubic yards of material.

*Photo 4. View east across Animas River at proposed pipeline crossing (ID: 4). Photo taken 4/22/2022.*

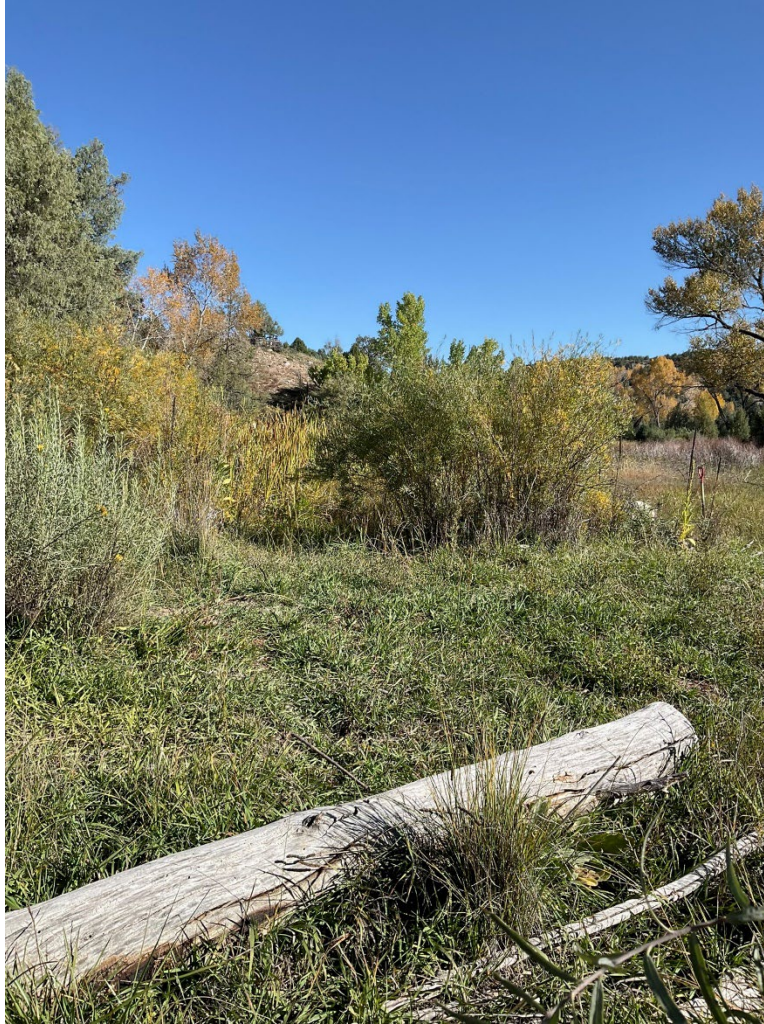
Wetlands occur within the active floodplain of the Animas River and are classified by Cowardin, et al. (1979) as Freshwater Forested/Shrub, Open Water, Palustrine Emergent, and Palustrine Scrub-Shrub. The wetland complex on the west side of the river was delineated by SECMG in the fall of 2022. Figure 2 of the Aquatic Resources Delineation Maps shows three wetland test pit locations on the west side of the river that were in the delineation process. In addition, the wetland determination data forms are included in Appendix B. The proposed pipeline ROW overlaps 131 square feet (0.003 acre) of Open Water, 3,354 square feet (0.077 acre) of Palustrine Emergent Wetland, and 3,093 square feet (0.071 acre) of Palustrine Scrub-Shrub Wetland.

Access to the east side of the river was denied, and an informal delineation of Freshwater Forested/Shrub Wetland there was completed using aerial imagery resources and the U.S. Fish and Wildlife Service's Wetlands Mapper. Approximately 3,459 square feet (0.079 acre) of this type of wetland has been mapped within the proposed pipeline ROW. The Temporary Use Area through the Animas River overlaps approximately 1,350 square feet (0.031 acre) of Freshwater Forested/Shrub Wetland.

*Photo 5. Representative photo of palustrine wetlands in the Animas River active floodplain.*

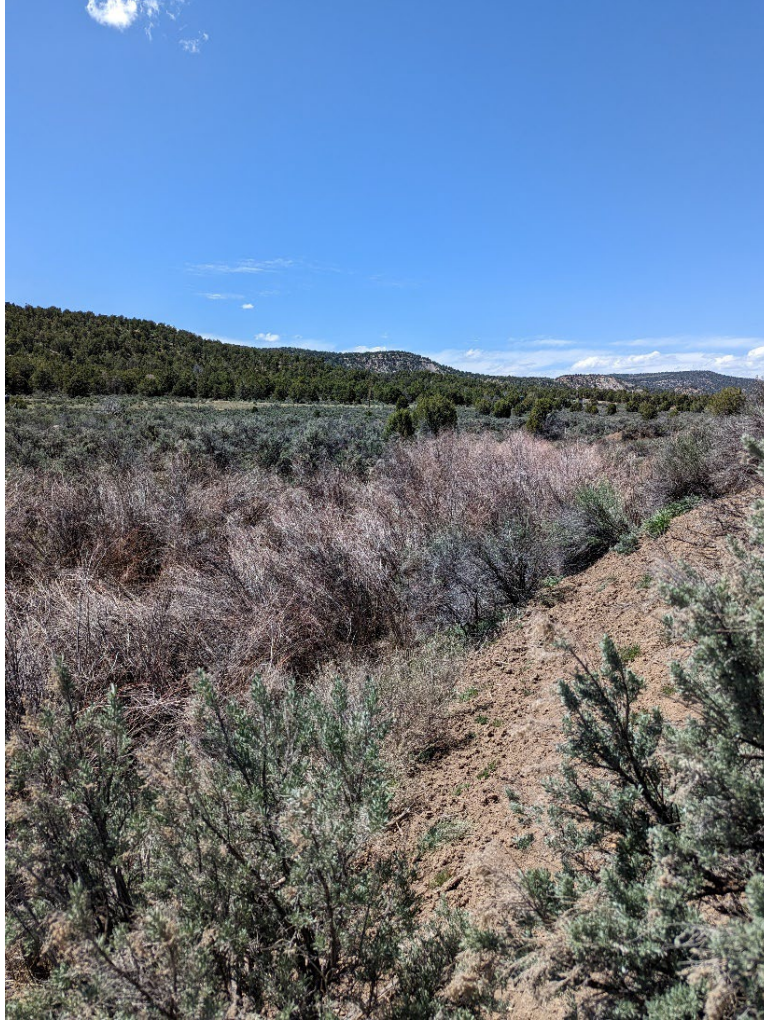
Cox Canyon flows north to south through the proposed pipeline ROW, eventually joining the Animas River near Cedar Hill. The channel is heavily vegetated with moderate scour and clear evidence of recent flows (see Photo 6 below). Surface water was not present at the time of evaluation, but evidence of temporary flooding and flowing water resulting from snowmelt and precipitation events within the watershed was observed.

The western bank abruptly transitions to upland vegetation consisting mostly of big sagebrush and the eastern bank has a less abrupt transition to the same desert scrub vegetation community. Identifiable vegetation within the channel consisted of patches of coyote willow, scattered sagebrush, and a dense ground cover of smooth brome (*Bromus inermis*) and forbs. No hydrophytic vegetation was present within the channel. The proposed pipeline is sited adjacent to a previously constructed pipeline through Cox Canyon located immediately up gradient. Evidence of the past pipeline construction included sloughing banks and reclamation of disturbances.

The delineation of the OHWM within Cox Canyon consisted of evaluating the drainage characteristics within the active floodplain, indicators of successional flow patterns (flood, low flow, and OHWM), and vegetative and sediment texture transitions. The OHWM delineation was based on large amounts of depositional litter and debris, oriented to the flow direction, which was at and above the OHWM. The limit of the active floodplain was observed by a pronounced change in surface elevation and a transition to upland sagebrush habitat. In addition, hydric soils and wetland hydrology are absent. The active floodplain was determined to be approximately 75 feet across at the proposed pipeline crossing. Therefore, the project would result in approximately 300 square feet (0.007 acre) of temporary disturbance to this resource, classified by Cowardin, et al., as Riverine – Intermittent – Streambed – Seasonally Flooded (R4SBC).

*Photo 6. Looking northwest into Cox Canyon, upstream from proposed pipeline crossing.*

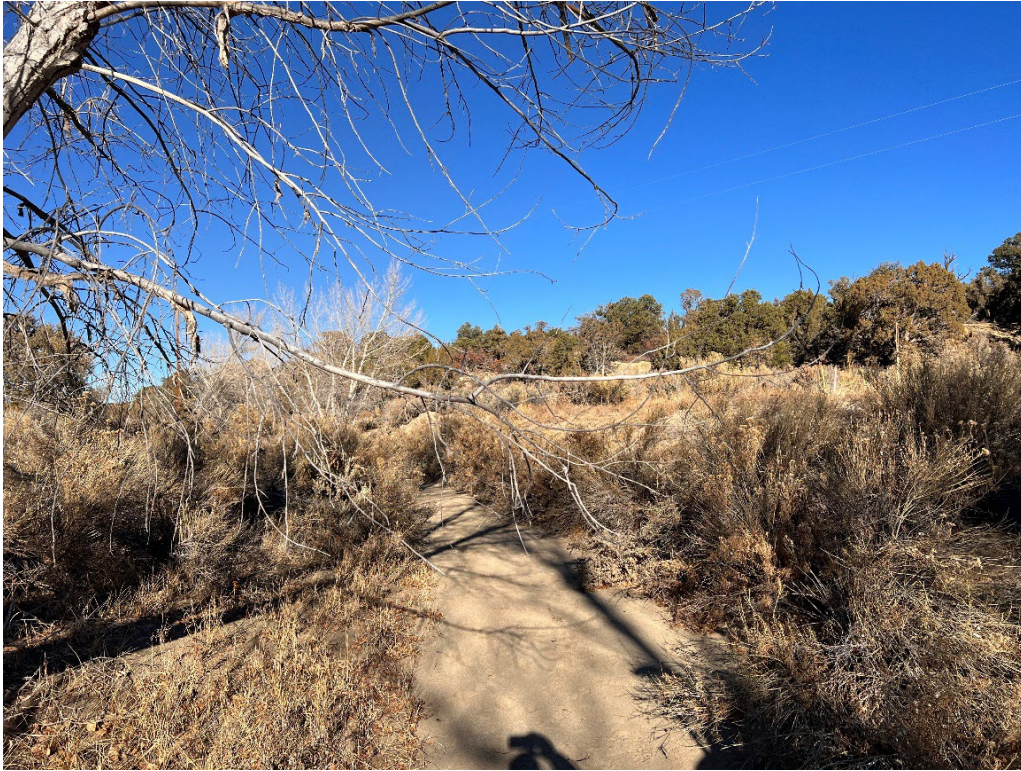
The delineation of the Unnamed Drainage II resource consisted of a cross section evaluation of the drainage within the proposed pipeline disturbance area. The evaluation consisted of documenting drainage characteristics, including indications of successional flow patterns (flood, low flow, and OHWM), vegetative transitions, and sediment texture transitions. Hydrophytic vegetation, hydric soil and wetland hydrology are absent in this drainage. The drainage enters the proposed ROW from a culvert under an existing oil and gas lease road, approximately 250 feet up gradient. This drainage flows

southwesterly for approximately 0.35 miles, where it joins Cottonwood Canyon. Cottonwood Canyon is a tributary to Cox Canyon, which discharges to the Animas River. The Cowardin classification of Unnamed Drainage II is R4SBA: Riverine, Intermittent, Streambed, Temporary Flooded.

Photo 7. Looking northwest into Unnamed Drainage II.

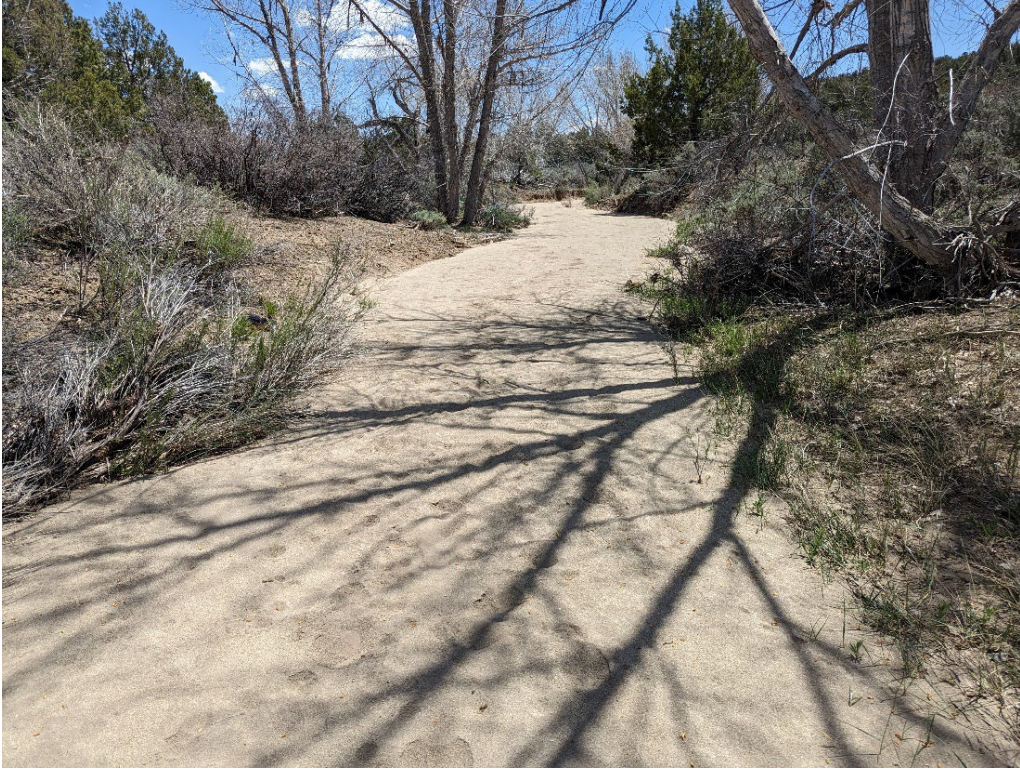
The delineation of Cottonwood Canyon (9a and 9b) also consisted of a cross section evaluation of the drainage within the proposed pipeline disturbance (Photos 8 and 9) area. Delineation of Cottonwood Canyon at 9a (station 343+54.35) displays similar OHWM features as the previously discussed *Unnamed Drainage II* and consisted of a similar evaluation of the drainage characteristics, indicators such as successional flow patterns (low flow, active and terrace floodplain, and OHWM), vegetative transitions and sediment texture transitions. However, delineation of Cottonwood Canyon at 9b where the ROW would parallel the drainage for approximately 85 feet displayed different characteristics. The active channel is dynamic with unconfined flow paths, resulting in a wide mosaic of low-flow channels, active and terrace floodplains. The drainage at this station also displays erosional and depositional features seemingly in consistent flux, such as colluvial deposits, headcuts and channels separated by islands. Big sagebrush, shrubs and upland forbs and grasses dominate the upland areas and are scattered within the low flow channel and active flood plain. No hydrophytic vegetation, hydric soil or wetland hydrology is present in this drainage. The drainage enters the proposed ROW from a culvert under an existing oil and gas lease road, approximately 200 feet up gradient from ROW crossing at 9a. Cottonwood Canyon continues southeast for approximately 8 miles to discharge to the Animas River. The Cowardin classification is R4SBA: Riverine, Intermittent, Streambed, Temporary Flooded. Temporary impacts to Cottonwood Canyon would be approximately 400 square feet (0.009 acre)

*Photo 8. Looking upstream at Cottonwood Canyon drainage crossing 9b.*

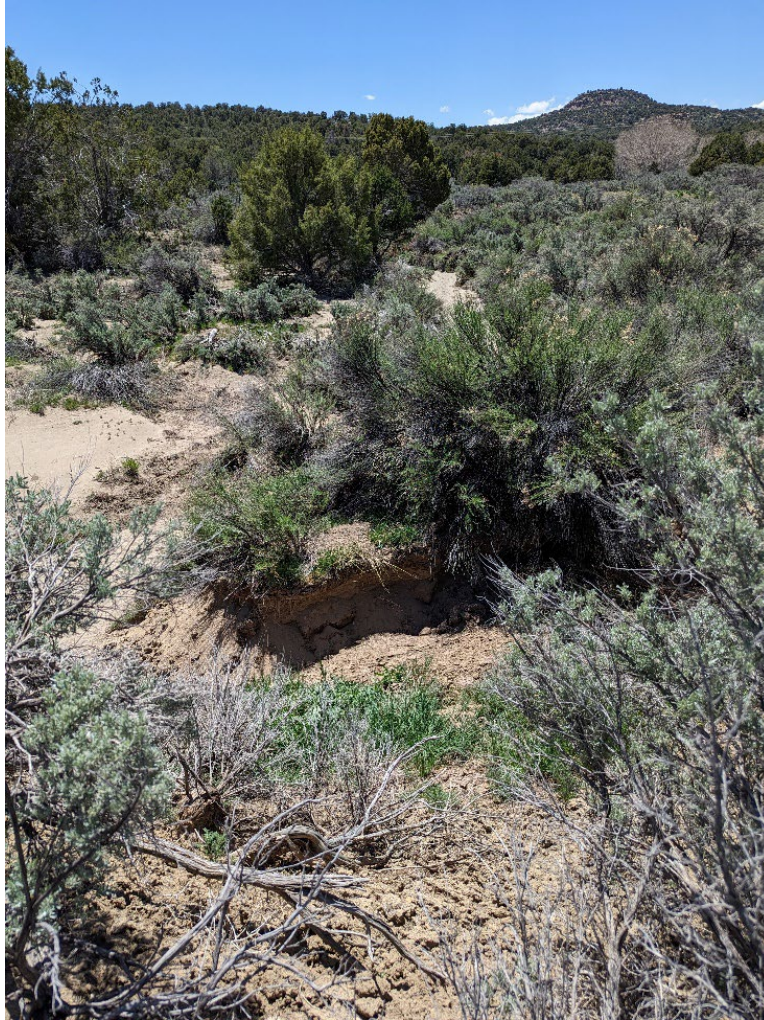
Photo 9. Looking upstream at Cottonwood Canyon drainage crossing 9a.
